MS4 NPDES PERMIT Pollution Reduction Plan (PRP)

**Prepared By:
Shoup Engineering, Inc.
329 Summerfield Drive
Baden, PA 15005**

In accordance with the 2018-2023 Permit, Richland Township must prepare and implement a Pollution Reduction Plan (PRP) to reduce sediment and nutrient loadings to various streams in the Township which are impaired due to existing sediment or nutrient loading. For Richland Township, impaired streams include portions of the West Branch of Deer Creek, Crouse Run, Montour Run and Breakneck Creek.

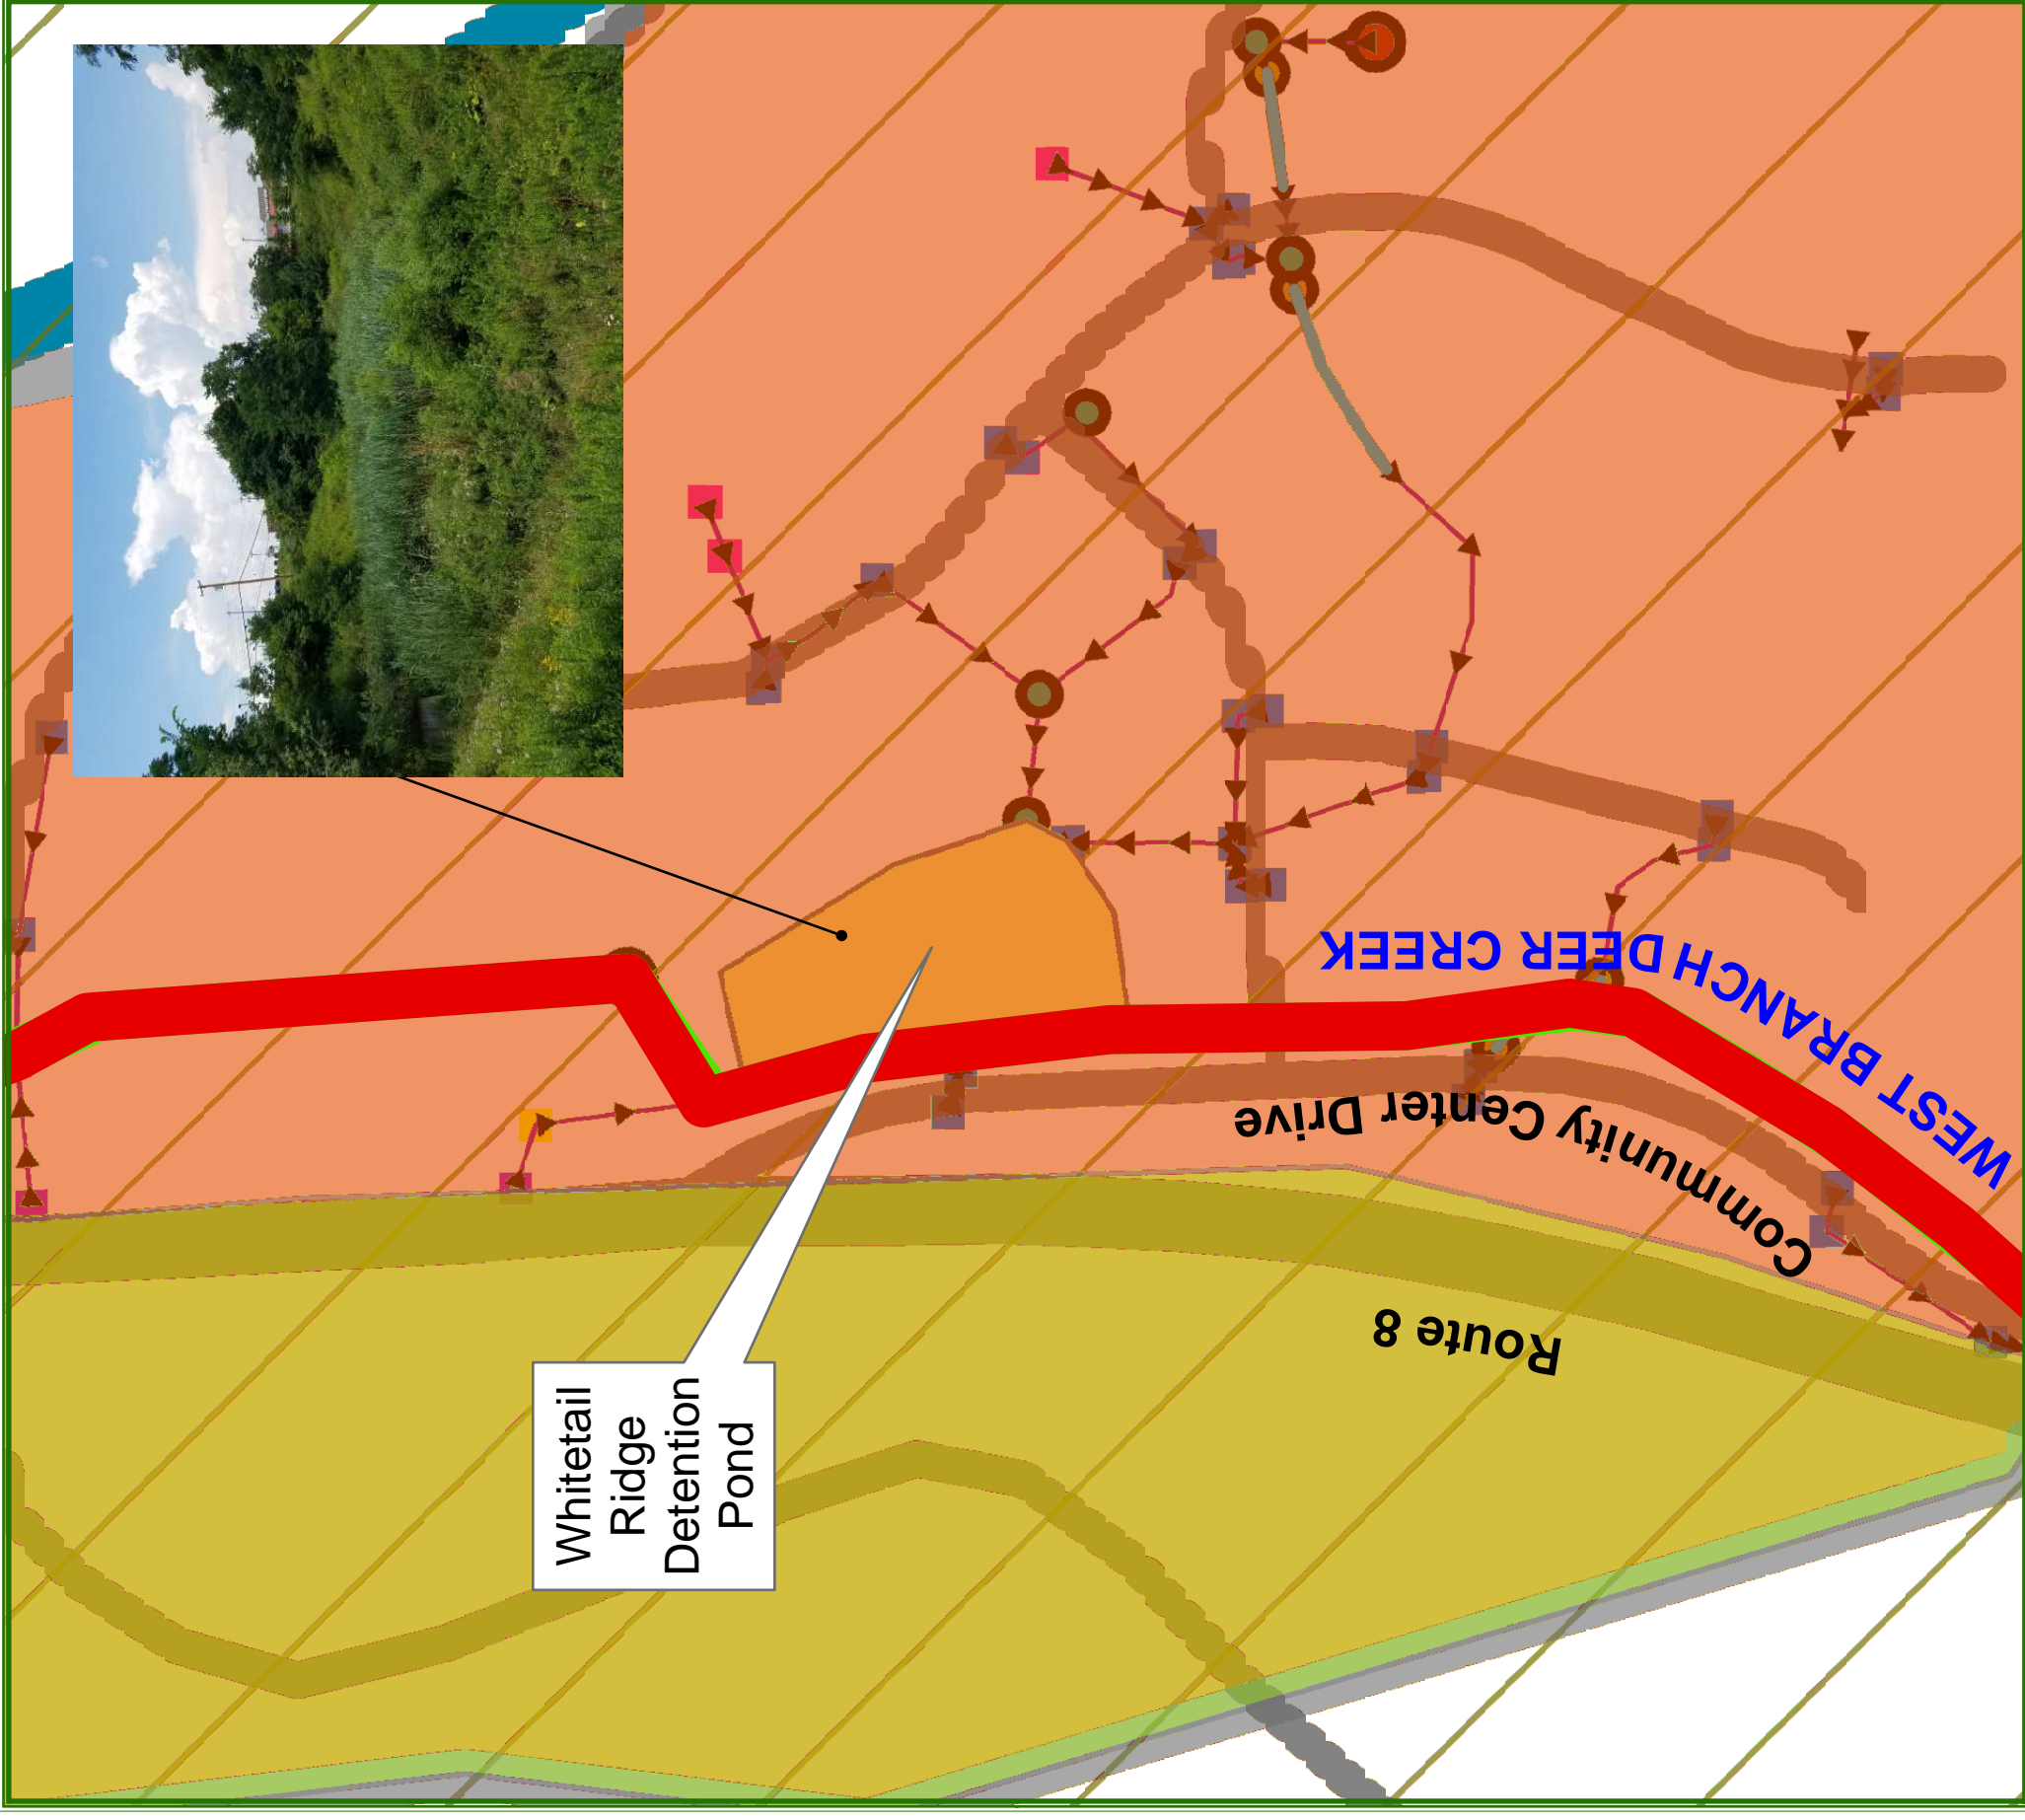
MAP #9

In the West Branch of Deer Creek watershed, an existing stormwater detention pond (built prior to the PADEP's 2003 Regulations) exists which may also be a cost effective candidate for retrofitting to a dry extended detention basin and/or wet pond. This detention pond known as the Whitetail Ridge (formally Colony Court) detention pond located east of Community Center Drive and north of Paul Revere Drive. Although stream restoration projects are selected as the primary BMP projects in this PRP for reducing sediment and TP loading in this watershed, the Township reserves the right to retrofit this detention pond as a secondary project which for a partial reduction in the needed number of stream restoration projects which will need to occur. The location of the Whitetail Ridge detention pond is shown on Map 9.

WHITETAIL RIDGE DETENTION POND RETROFIT PROJECT

For the retrofit of the Whitetail Ridge Detention Pond BMP project, the Township's Public Works Department will also be responsible for ongoing O & M. Inspections of the BMP shall be performed annually by the Township's MS4 Coordinator, Township Engineer or the Township's Public Works Superintendent. O & M activities to be performed following each inspection include but are not limited to; cutting and removal of excessive vegetation, removal of debris at inlet/outlet structures and removal and disposal of excessive sediment buildup.
